Manhole Inspection Summary

Manhole # S39AA1015MH

Insp Date: **12/13/06 10:51 AM**

Location Address: **751 MELVILLE AVE**

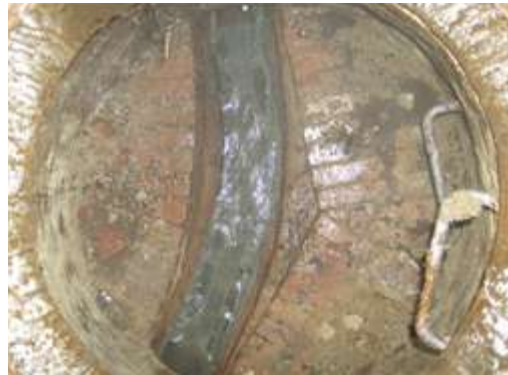
Top View

Barrel infiltration. Evidence of surcharge - Bench debris.

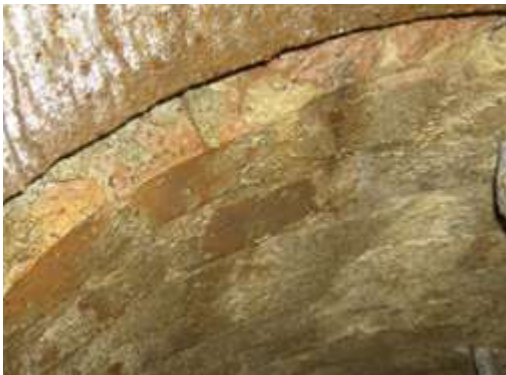
Defect

Frame leaks. Adjustment infiltration.

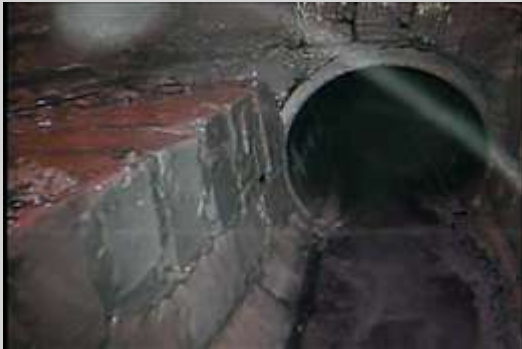
10 in. Circular Gravity Sewer Pipe Out @ 12 O'Clock

Invert Depth: **5.09** (ft.) Flow Characteristics: **Slow**

Deposits: ☒ None ☐ Mud ☐ Sludge ☐ Debris ☐ Grease

Infiltration: **None** Pipe Seal Cond: **Unknown**

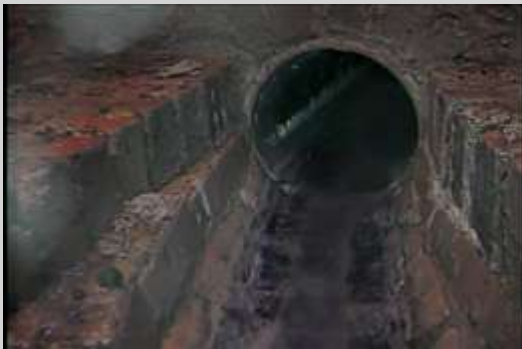
8 in. Circular Gravity Sewer Pipe In @ 7 O'Clock

Invert Depth: **5.09** (ft.) Flow Characteristics: **Slow**

Deposits: ☐ None ☐ Mud ☐ Sludge ☐ Debris ☒ Grease

Silt Depth: **0** (in.) Deposits Extent: **Light**
